PLASTER AND THE CALIFORNIA MISSIONS: TRADITIONAL CONSTRUCTION & RESTORATION

2911 N. ORANGE-OLIVE RD. ORANGE, CA 92865 714.637.7341
www.vero-rialto.com

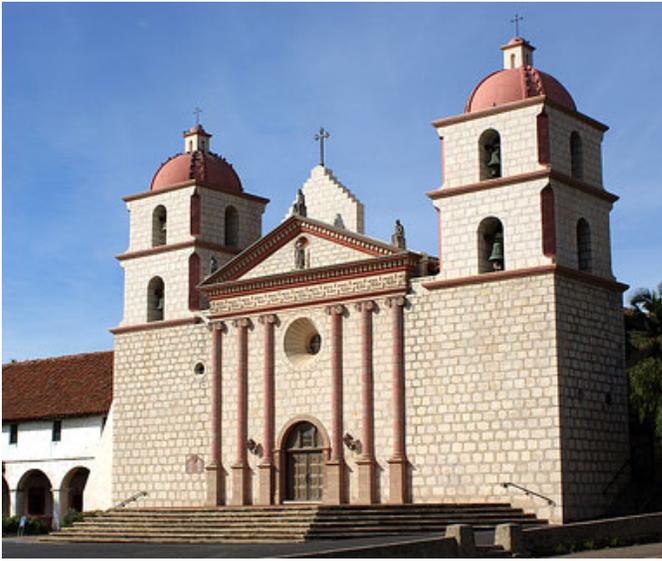
The Church at Mission Santa Barbara, made of stone

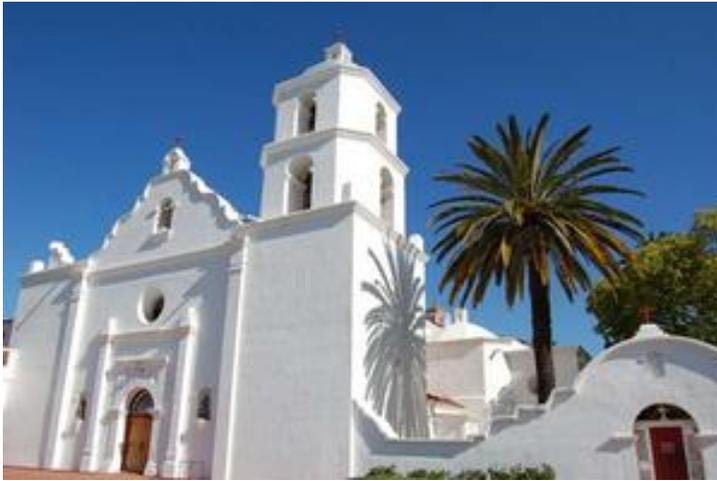
The church at Mission San Luis Rey, built with adobe and kiln-fired clay ladrillo bricks

Mission compounds were mixes of adobe blocks with limewash, structures of adobe and kiln-fired ladrillo bricks, and stone. The prosperity of the Mission at the time of construction and the function of the building determined the materials. “For important buildings such as the church and the convento, the final plaster would be made of lime, producing a hard and durable finish.”⁴ Ladrillos provided improved weather resistance and sharper lines that were not possible with adobe, and are widely used at Mission San Luis Rey (Oceanside), Mission San Antonio (Monterey County) and Mission San Diego. Prominent stone churches were built at Mission Santa Barbara, San Gabriel, and the now ruined San Juan Capistrano. Nothing made a prouder padre than building a stone church clad in white plaster.

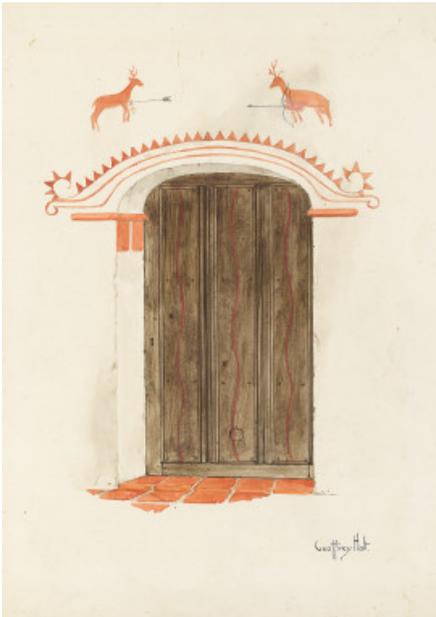
This wall painting came from Mission San Fernando Rey

While exterior walls were left simple and bare, interior walls were decorated extensively. Where Mission jobsites couldn't use expensive wood and stone features, they often painted them on the walls. "Dado" wainscots were common, as were painted cornices at the tops of the walls. "True *fresco* painting was rare in Alta California, identified only recently at the Royal Presidio Chapel in Monterey. This technique is executed on wet plaster, allowing the paint to bond with the wall surface and resulting in a more durable finish."⁵

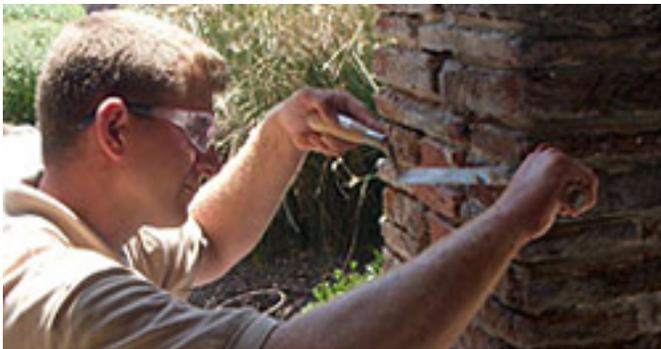
Restoration work at Mission San Juan Capistrano using lime mortars to repoint bricks

Restoration at Mission San Juan Capistrano, for example, strives to reproduce as closely as possible the original construction of the walls. “To reinstate the historic character of this area, removal of all inappropriate past repairs, mainly the use of cement, is a key element to the project. Work on the masonry columns includes the removal of hard cement mortar at the joints between the bricks and repointing with a softer, more compatible lime mortar.”¹²

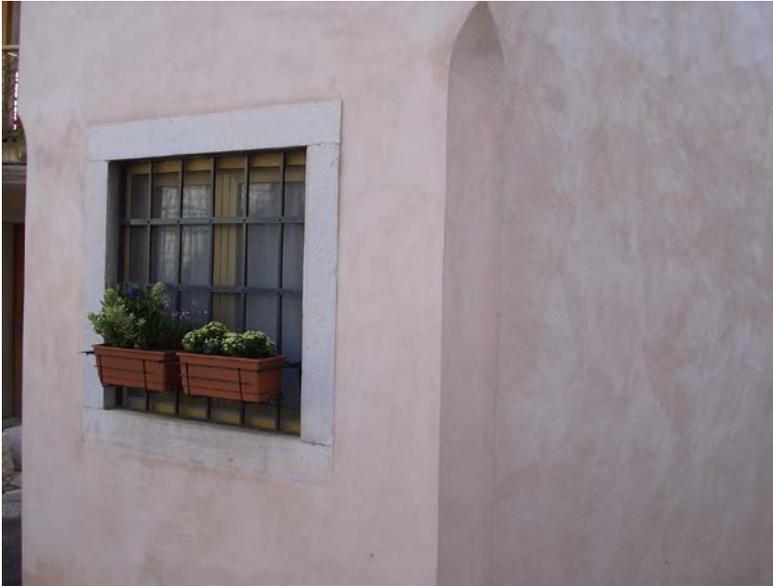
Malta Grezza & Malta Fine produce this characteristic pink tone when *Cocciopesto* is used to provide added water-resistance and faster set.

Thanks to their softness, breathability, and protective qualities, lime mortars, lime plasters, and lime washes are ideally suited to restoration of Missions and other buildings of similar construction. There are several products that have established themselves in this niche. Headquartered in Orange, California, Vero imports Italian seasoned-slaked lime mortars, plasters, and lime washes, produced in much the same way as those used by Vitruvius in Ancient Rome. Malta Grezza/Fine are ready-to-use lime mortars, and are made more weather-resistant through the addition of Cocciopesto (brick dust). This technique is consistent with that used for reservoirs and fountains in the California Missions,

which “were often rendered with water-resistant *coccio pesto*, hydraulic lime stucco made pink by the admixture of ground terracotta tiles, another Vitruvian formula. *Coccio pesto* was also used on architectural elements, such as the *ladrillo* colonnade columns at Mission Santa Ines.”¹³
